To: All RedMax Distributors and Dealers
Subject: EBZ7500, EBZ7500RH, EBZ8500 & EBZ8500RH
Instruction for preventing Crank Case Damage

PRODUCT MODEL	PRODUCT SERIAL NUMBER
EBZ7500 (966 62 43-01)	EBZ7500 : Up to #20799999
EBZ7500RH (966 70 99-01)	EBZ7500RH : Up to #20799999
EBZ8500 (966 62 45-01)	EBZ8500 : Up to #20799999
EBZ8500RH (966 71 00-01)	EBZ8500RH : Up to #20799999

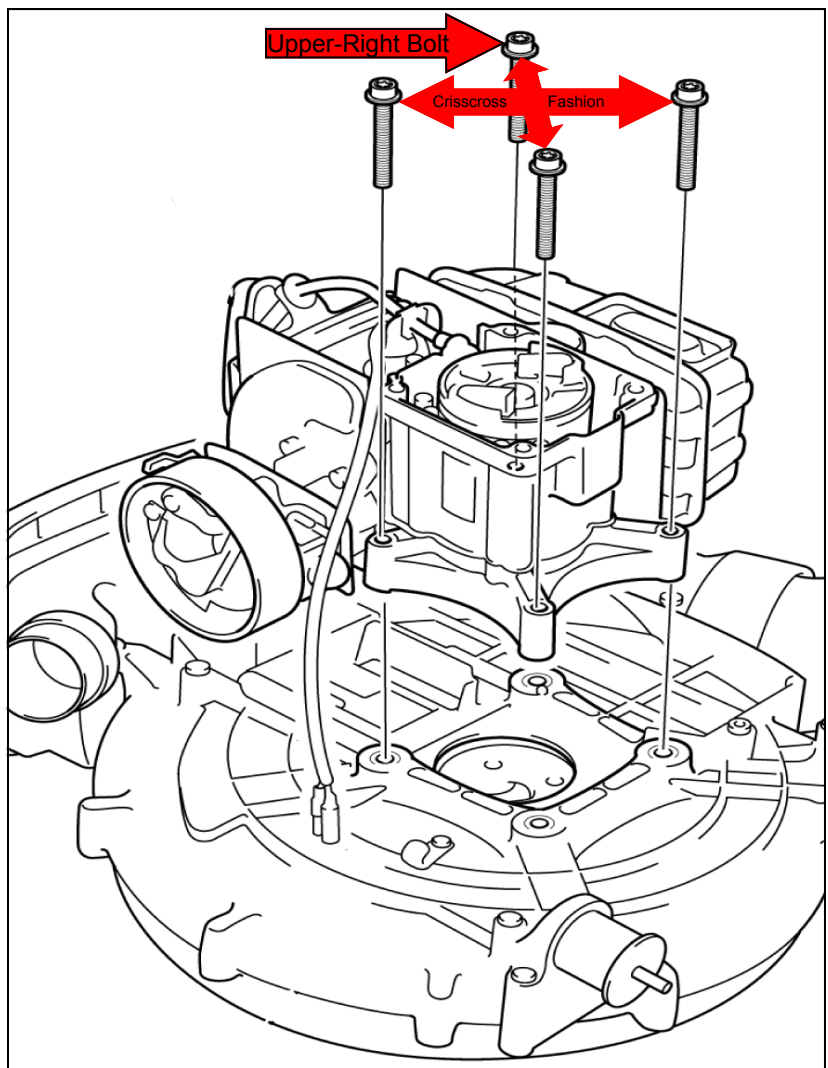
RedMax received field reports that one of the bolts securing engine crank case to fan (volute) case may come loose. The bolt location is in the upper right hand corner on the muffler side of the engine, see Fig. 1 below.

Fig. 1: Retighten 4 bolts in crisscross fashion

To correct the problem, the assembly process has been improved to eliminate the above issue, starting with August 2012 production and units with serial number 20800000 and above.

Should you have units in stock with serial number below 20799999, please retighten all 4 bolts in crisscross fashion as specified in Fig.1 using T-27 bit or wrench to tightening torque of 55-65 Inches-lbs. or 4.6 to 5.5 ft.-lbs.
