SB, Ignition module – Boot grounded to cylinder, EBZ7500, EBZ7500-RH, EBZ8550, EBZ8550-RH, 2021-10

**Service Bulletin
B2210004A-15**

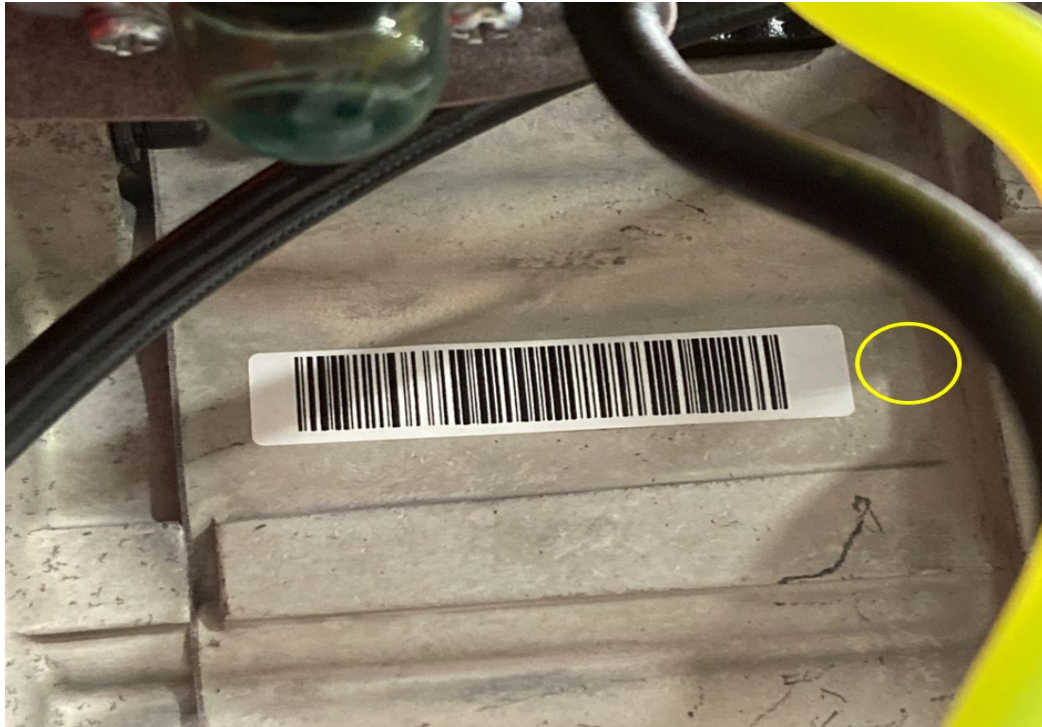
Figure 4: Position for punch mark on crankcase.

3. After inspection, take a spring loaded punch and create a light mark just to the right of the engine SN decal (area represented by the yellow circle in figure 4 below) on the crankcase to indicate that the unit has an acceptable ignition coil.
