SB, EBZ7500/8500, Crankcase Torque, 2013-09

EBZ7500 966624301, EBZ7500RH 966709901, EBZ8500 966624501, EBZ8500 966710001

Introduced in production from 11200000 - 30910000

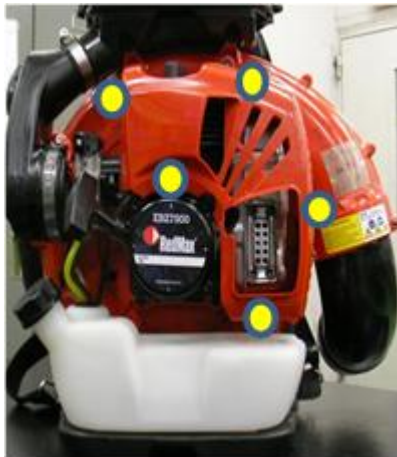
In order to improve the integrity of the crankcase to volute cover joint a higher torque has been established for the above stated models. Detailed instructions are included below.

Step 1 Remove engine cover. Loosen and remove five self-tapping screws.

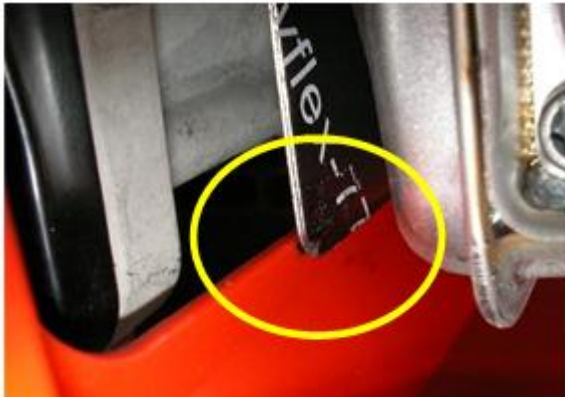
GOOD

Caution needs to be taken to ensure correct position of the exhaust gasket.

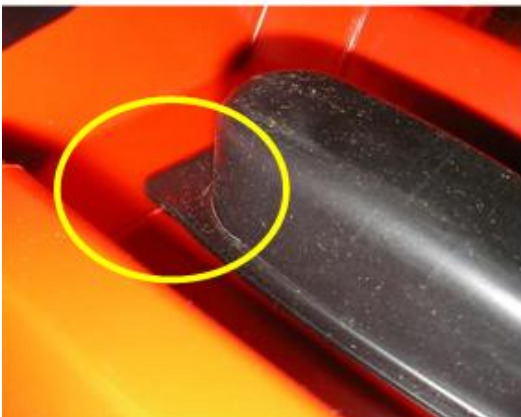
GOOD

Also pay attention to the spark plug cover.
