## SB, Missing alignment hole in straight shaft tube, Edger Accessory Attachment, 2020-11

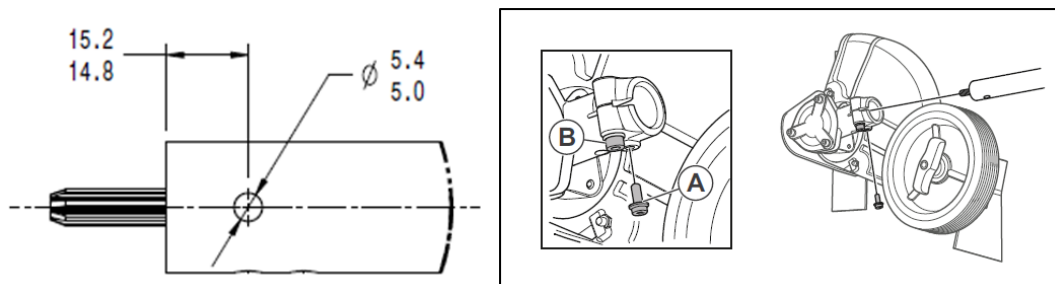
Figure 1:

Some products were shipped missing the pre-drilled alignment hole that the tube uses as an aid for aligning and constraining the edger head in the proper location. If the tube assembly was provided without this pre-drilled hole, a replacement tube assembly may be needed for correction.

Note: As indicated in figure 2, this set hole is in line with the rectangle slot in the opposite end. Also, note, there are 2 holes in line from each other, rotated 90° from this expected position.

Product sold to end user	Residual inventory not yet sold
What is required:	Service is required.	Inspection is required.
When to do:	Only if encountered.	At pre-delivery inspection.
What to do:	Follow instructions below when encountered.	
How to do:	Order a replacement tube assembly and replace.
